# Manhole Inspection Summary

Manhole # S17GG2014MH

Insp Date: **10/20/06 8:38 AM**

**Location** Address: **5910 SMITH AVE**

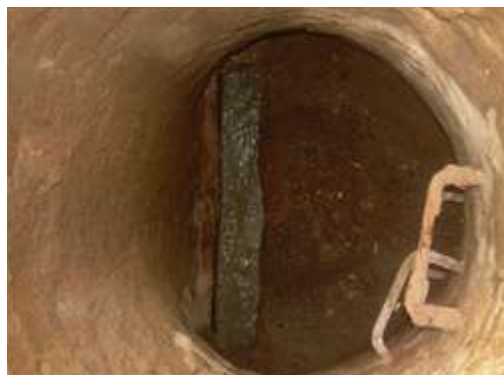
Top View

Corroded steps. Evidence of surcharge - Bench debris.

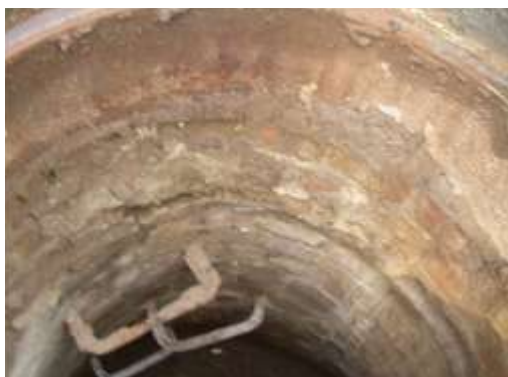
Defect

Frame leaks. Frame offset. Adjustment deterioration and infiltration. Corbel and Barrel infiltration.

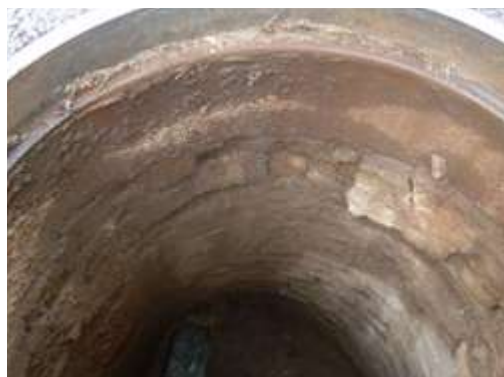
Defect

Frame leaks. Frame offset. Adjustment deterioration and infiltration. Corbel and Barrel infiltration - other side.

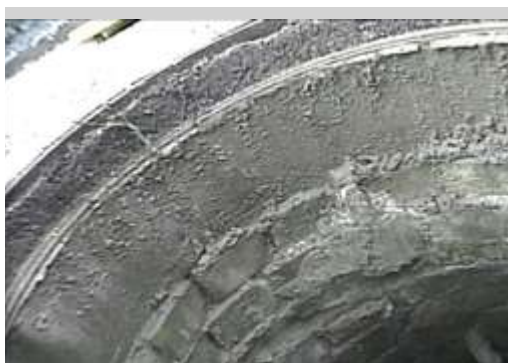
Defect

Frame leaks. Adjustment deterioration and infiltration.
